Manhole Inspection Summary

Manhole # S25G__026MH

Insp Date: **3/31/08 9:42 AM**

Location Address: **1126 W Fairmount AV**

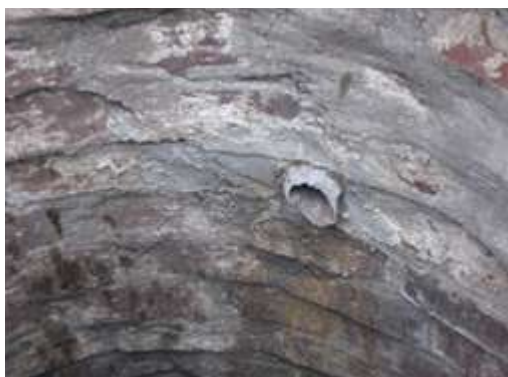
MISCELLANEOUS

broken blow out valve

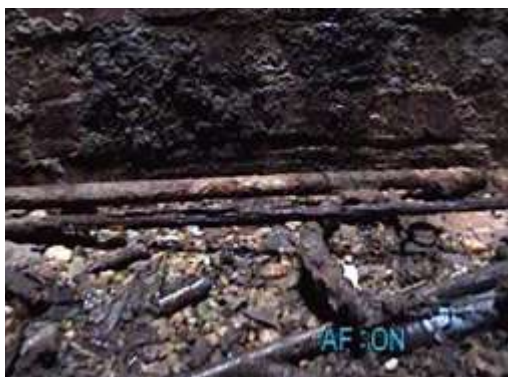
Defect 2

Condition: ☐ Sound ☐ Cracked ☐ Root Intrusion ☐ Deteriorated ☐ Leaks ☒ **Debris**

channel debris

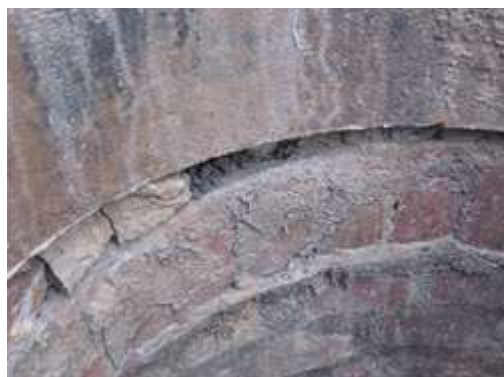
Defect 1

Condition: ☐ Sound ☐ Cracked ☐ Root Intrusion ☐ Loose Brick ☒ **Deteriorated**

Infiltration: ☐ None ☐ Joint ☐ Cracks ☒ **Mortar** ☐ Roots ☐ Wall

chimney deteriorated with signs of flow at mortar

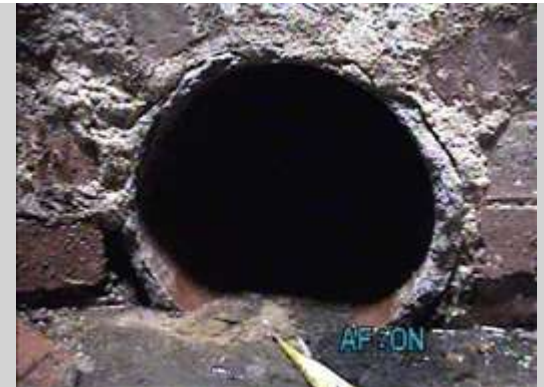
12 O'Clock Outflow

8 in. Circular Gravity Sewer
Pipe Out @ 12 O'Clock
